# Manhole Inspection Summary

Manhole # S17E\_\_008MH

**Location** Address: **212 BENTALOU** Cross Street: **SARATOGA ST**

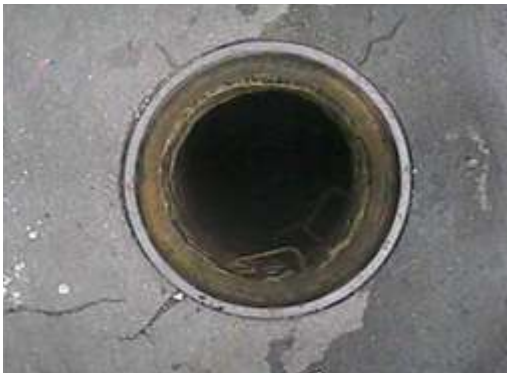
Top View

**Frame** Offset: **1** (in.) Condition: ☒ Sound ☐ Cracked ☐ Leaks

**Steps** Count: **10** Missing: **0** ☒ **Corroded**

FRAME OFFSET/STEPS CORRODED

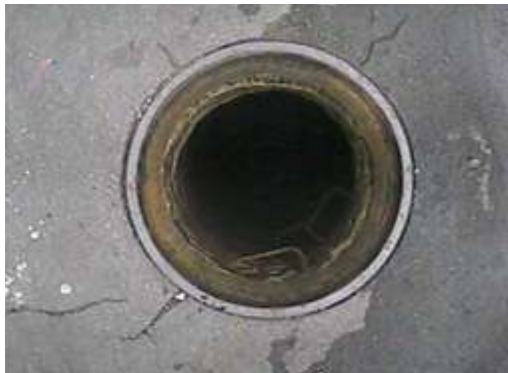
Defect 1

FRAME OFFSET

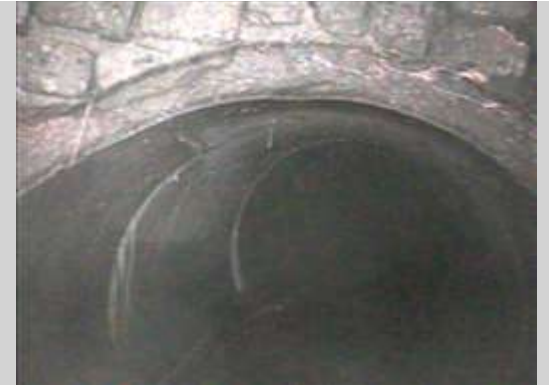
12 O'Clock Outflow

27 in. Circular Gravity Sewer  
Pipe Out @ 12 O'Clock

Pipe Height: (in.) Direct  
Pipe Material: **Concrete** ☐ Pipe Lined  
Invert Depth: **21.04** (ft.) Flow Characteristics: **Fast**  
Deposits: ☒ None ☐ Mud ☐ Sludge ☐ Debris ☐ Grease  
Silt Depth: (in.) Deposits Extent:  
Infiltration: **None** Pipe Seal Cond: **Sound**

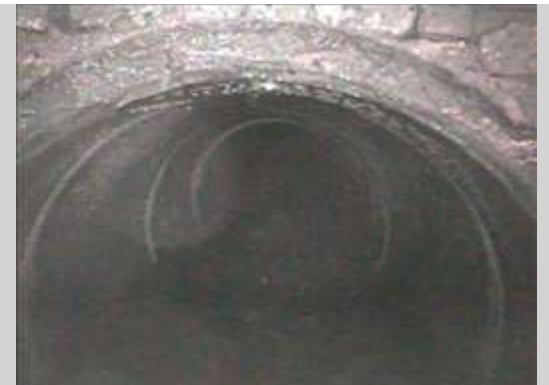
6 O'Clock Inflow

27 in. Circular Gravity Sewer  
Pipe In @ 6 O'Clock

Pipe Height: (in.) Direct  
Pipe Material: **Concrete** ☐ Pipe Lined  
Invert Depth: **21.14** (ft.) Flow Characteristics: **Fast**  
Deposits: ☒ None ☐ Mud ☐ Sludge ☐ Debris ☐ Grease  
Silt Depth: (in.) Deposits Extent:  
Infiltration: **None** Pipe Seal Cond: **Sound**

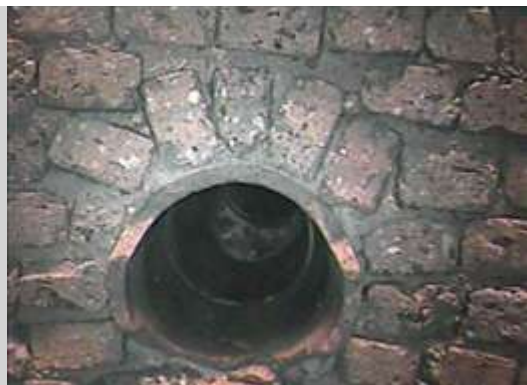
9 O'Clock Inflow

8 in. Circular Gravity Sewer

Pipe In @ 9 O'Clock

Infiltration: **None** Pipe Seal Cond: **Sound**

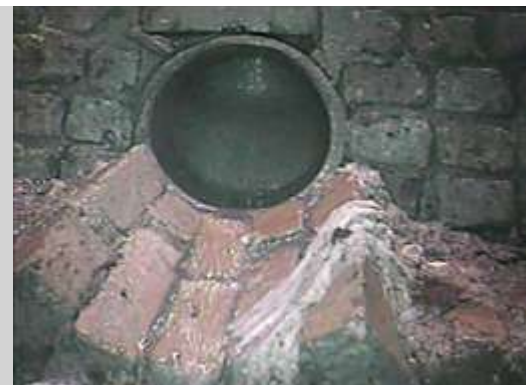
Drop In @ 9 O'Clock

Drop: **Inside** **Direct**

Inv Depth: **18.62** (ft.)

Drop Condition: **Open**
